Pit 101T – Reclamation (Figures 1-10)

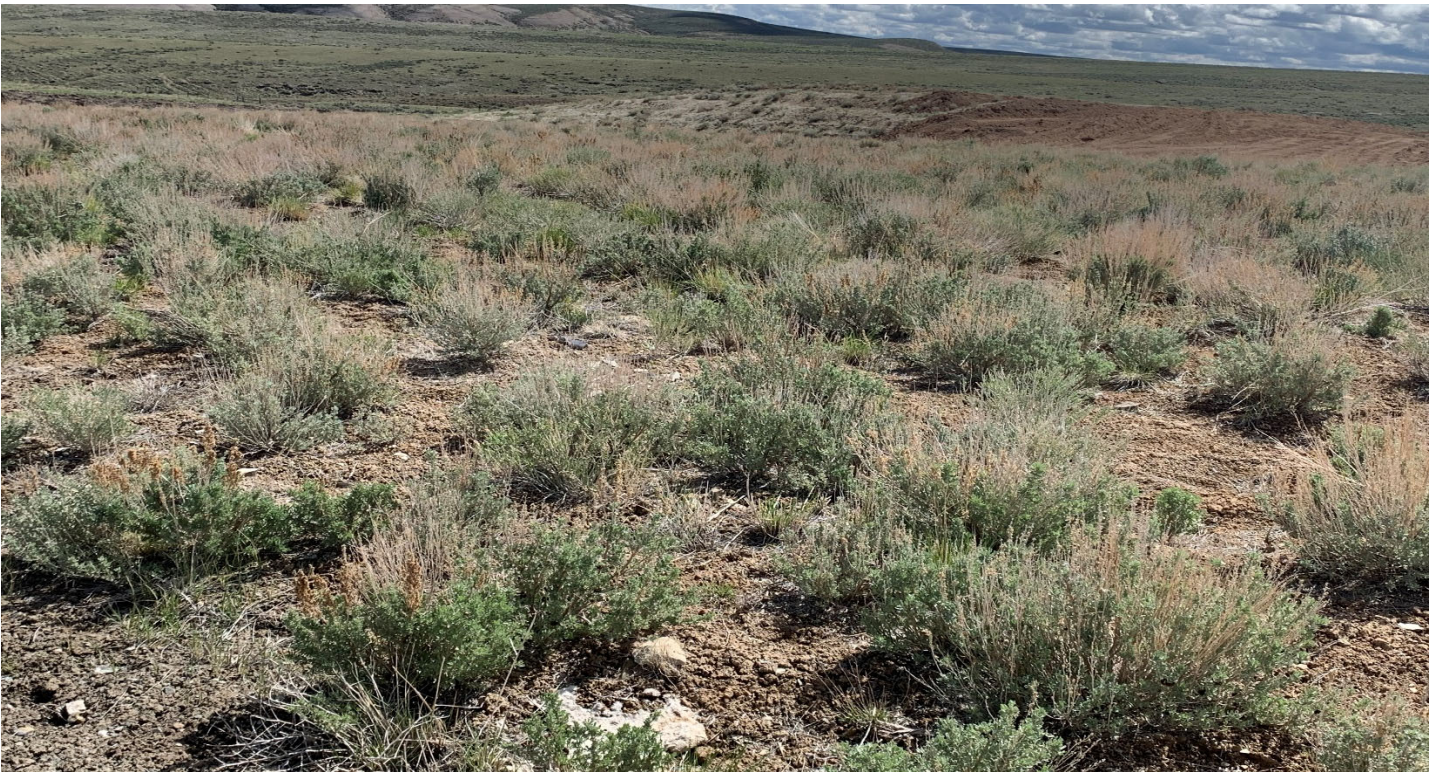
Figure 2: This Wyoming Big Sagebrush was seeded in the winter of 2016. The seed was broadcasted onto the snow surface during the winter months using an ATV with a mounted broadcast spreader. This picture is taken on the western edge of Pit 101T looking to the southwest.

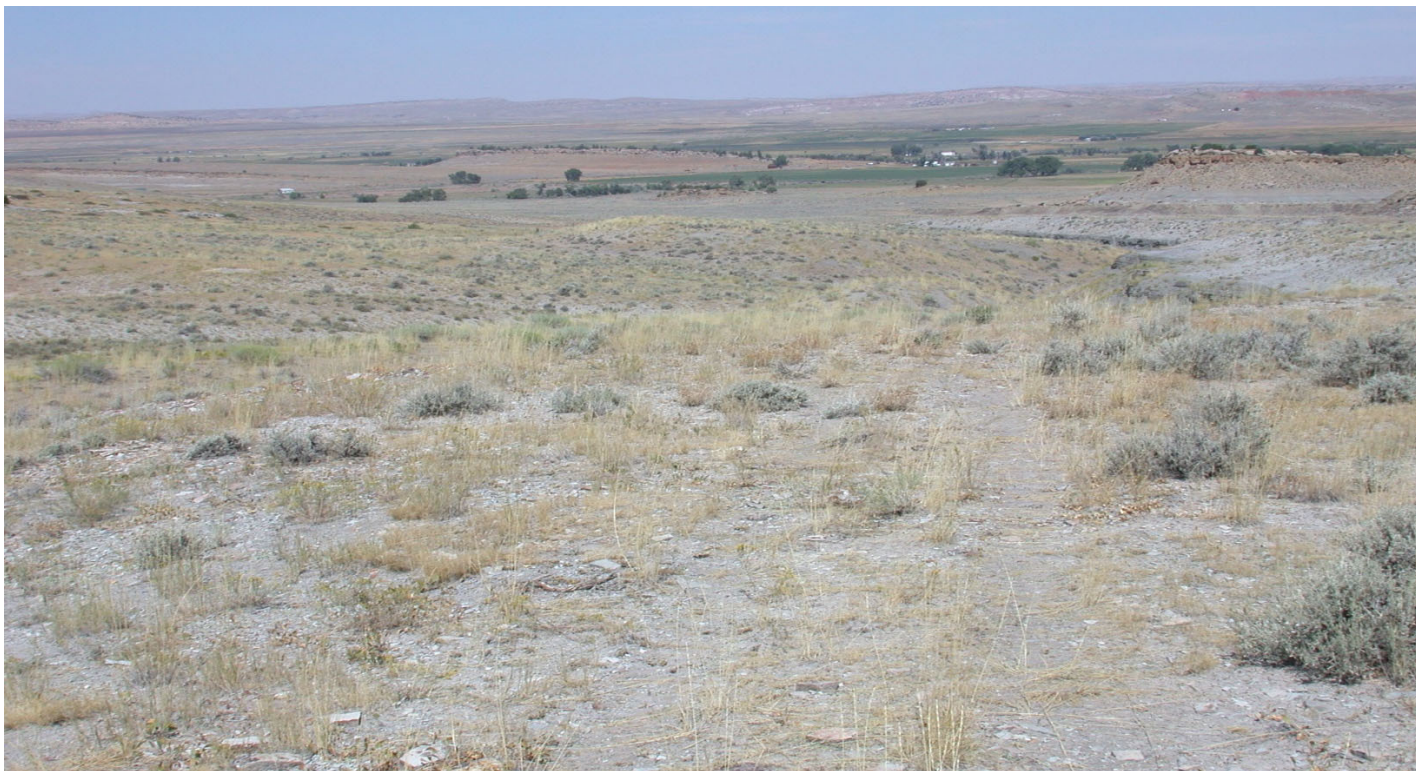
Figure 3: Typical pre-mine vegetation on the bentonite outcrop for 101T and 101T Extension. (Sept 2008)

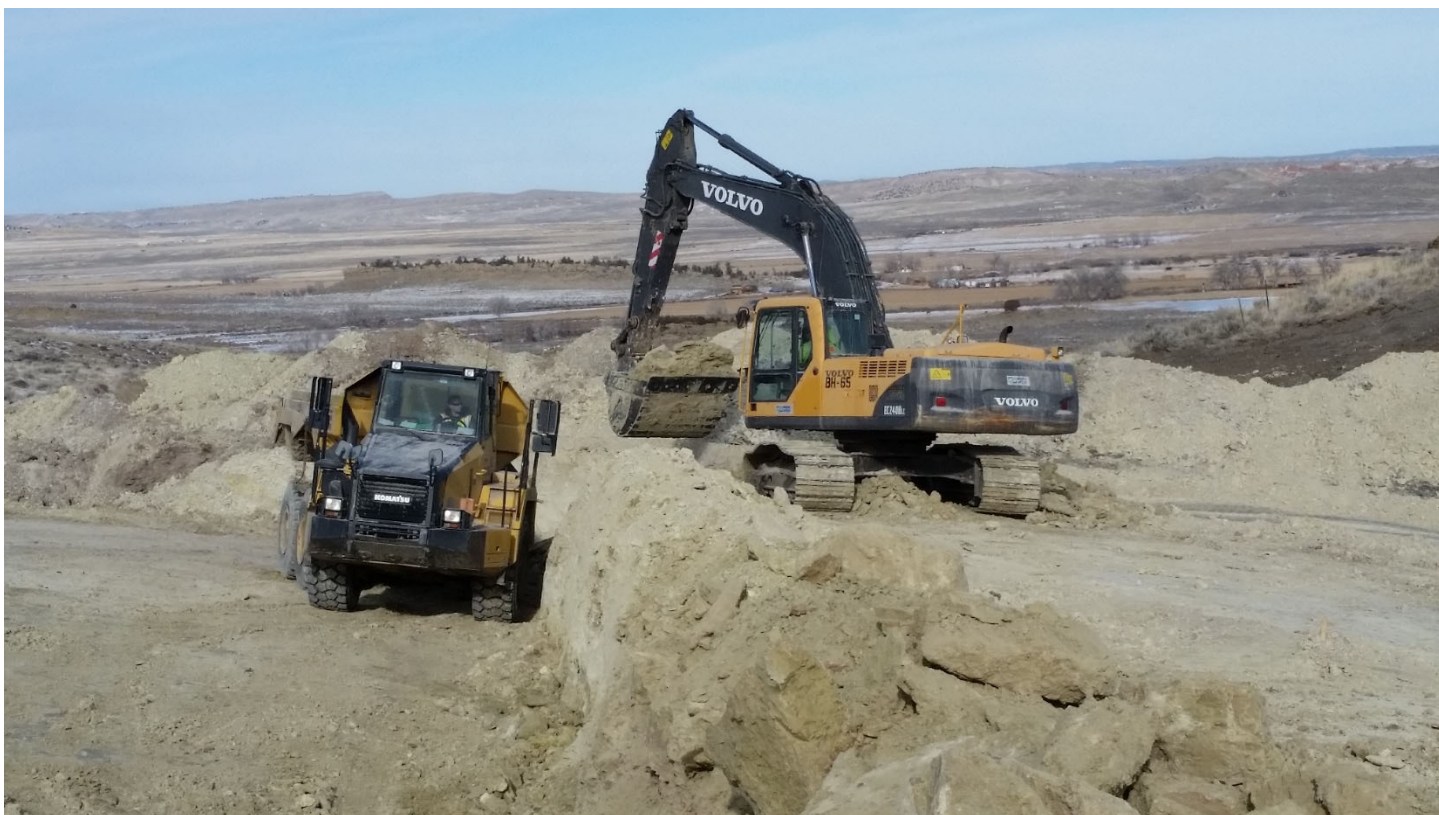
Figure 4: Removal of bentonite from Pit 101T Ext after the topsoil and subsoil has been removed (Jan 2016)

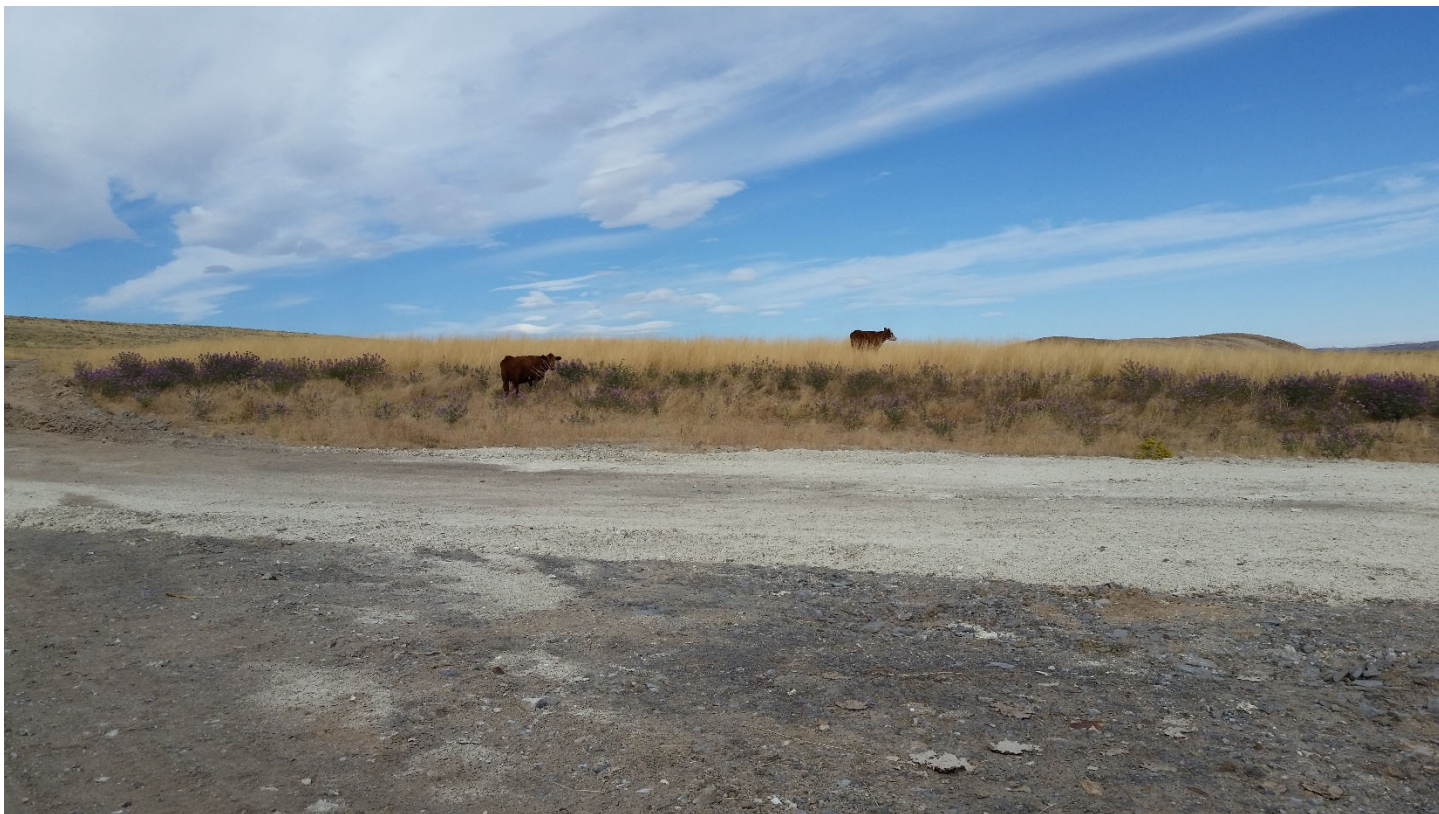
Figure 5: Reclamation located on the western edge of Pit 101T looking to the east, seeded in 2013. The foreground was an active bentonite stock pila area at the time of the picture. (Sept 2015)

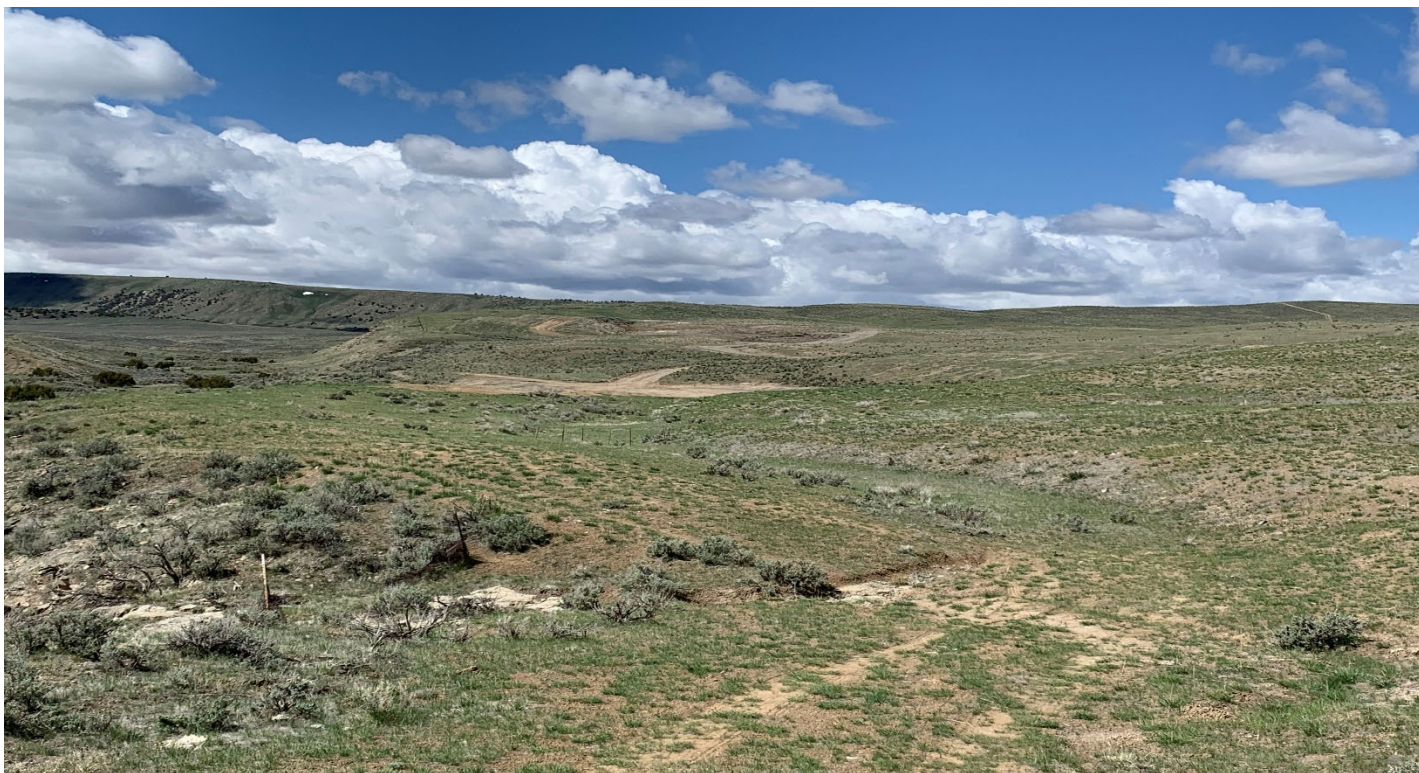
Figure 6: Looking across the reclaimed Phase 1 of Pit 101T. Vegetation is just beginning to green up after a long winter. The succession of the reclamation since 2013 has included landscape dominated with Rocky Mountain Bee Plant in 2014, Sunflower in 2015, and has become a favorite of the cows in the summer and fall months (May 2021)

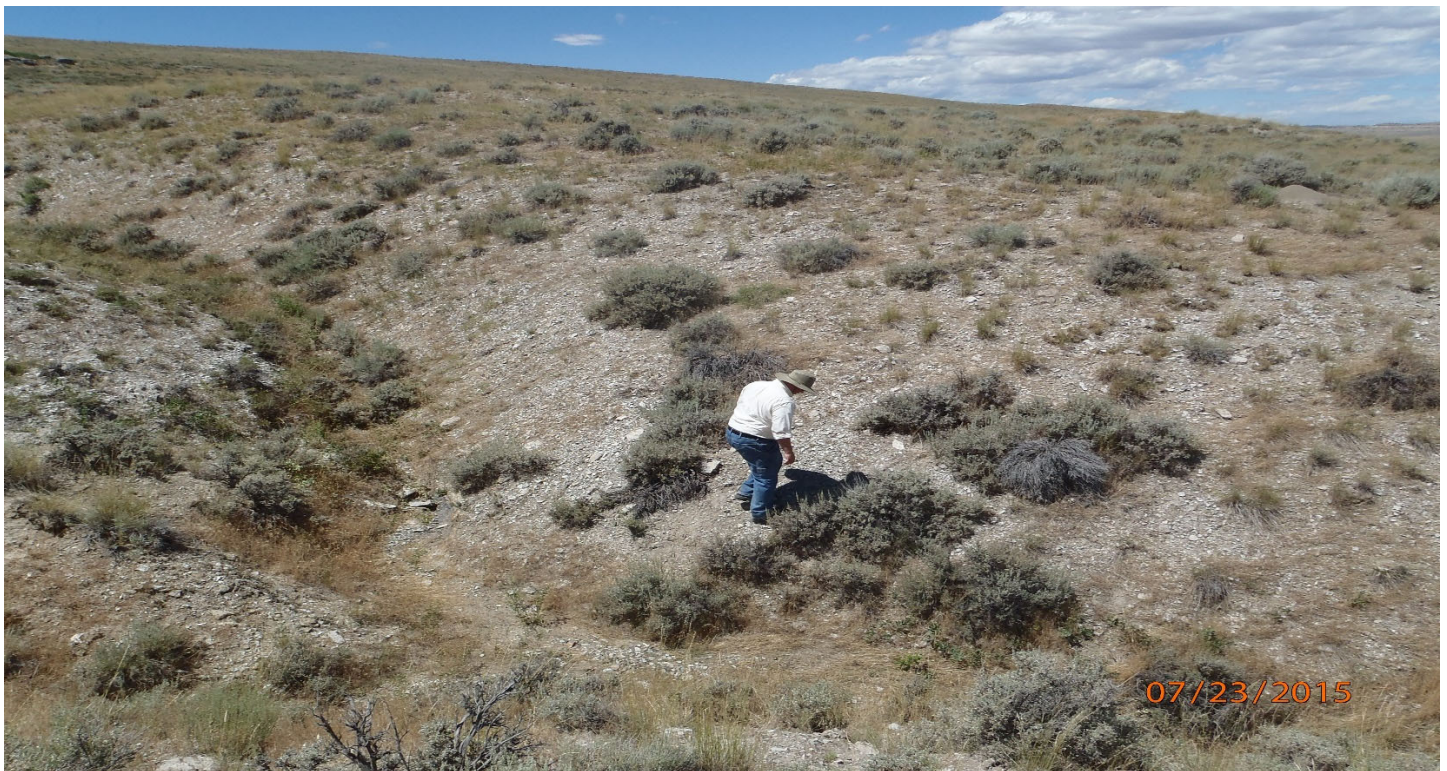
Figure 7: Matt Call, Environmental Supervisor, inspecting a nest that was discovered during a required nest search prior to any new disturbance from March 15 to July 15 at Pit 101T Ext. (July 23, 2015)

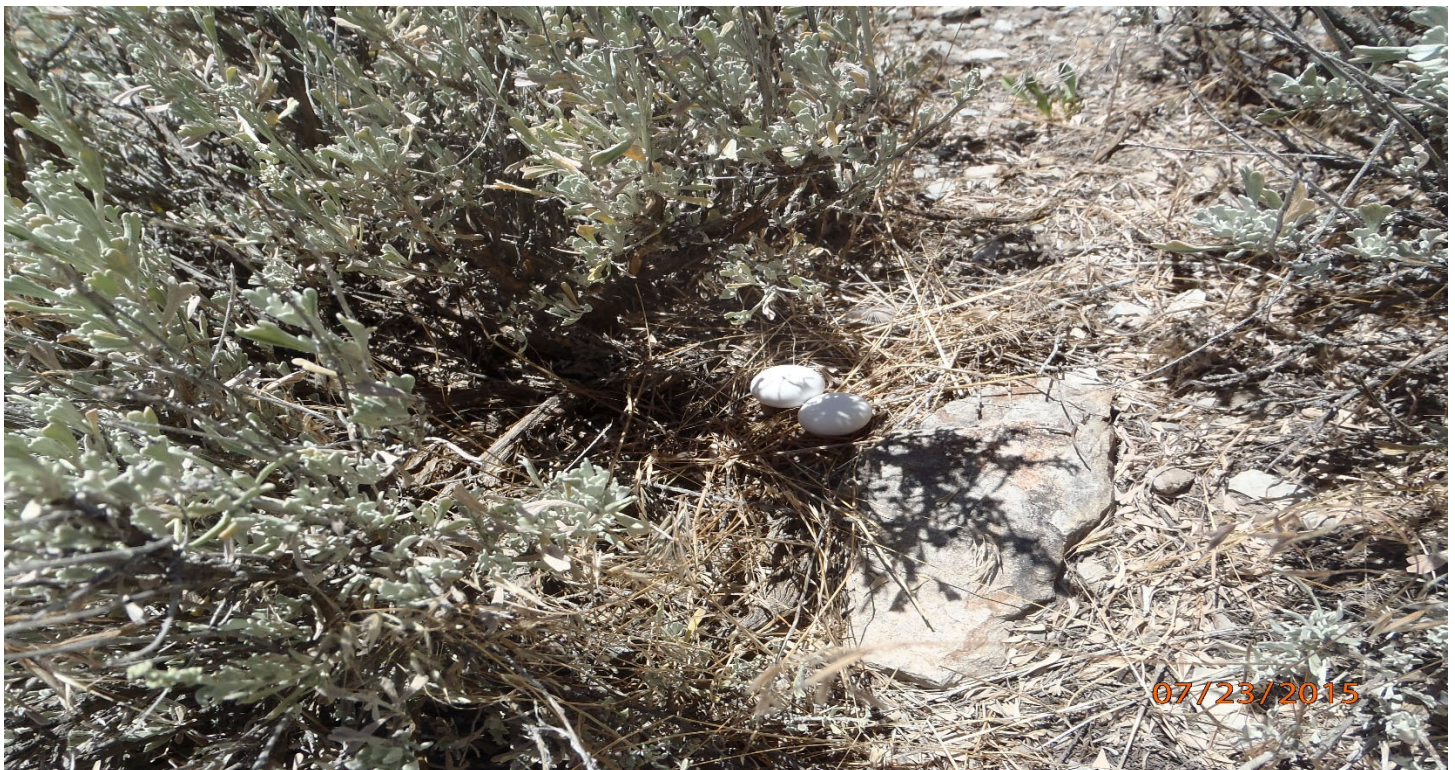
Figure 8: Image of the nest that was discovered at Pit 101T EXT on July 13, 2015. Initially there was only one egg and upon inspection on July 23, a second egg was discovered in the nest. These eggs successfully hatched and fledged the nest. (July 23, 2015)

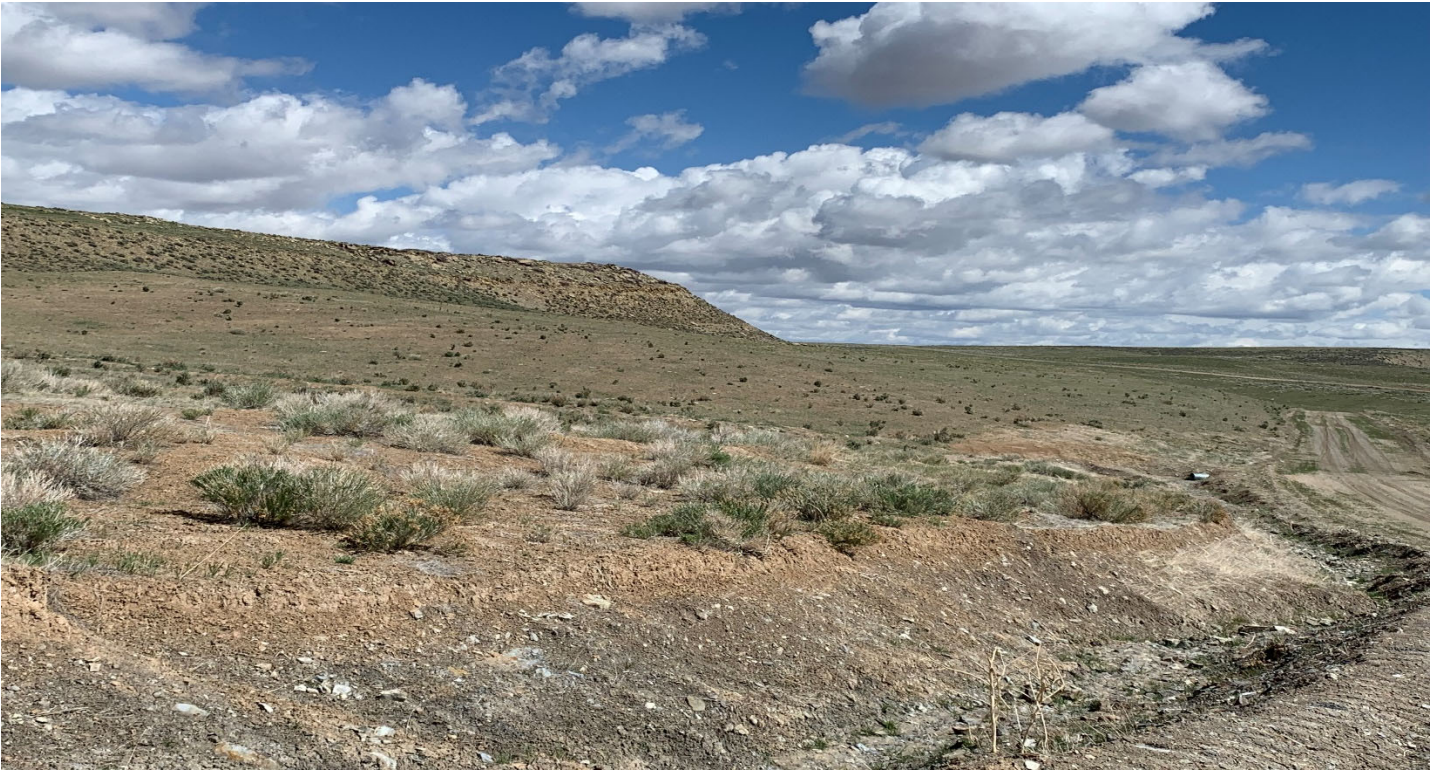
Figure 9: From the western edge of Pit 101T looking across the areas that were seeded in 2013, 2015, and 2016 to the east. On the right-middle of picture is a culvert in the haul road. Just above the culvert to the left is the drainage that was blown out in 2016. Drainage was reconstructed and seeded in 2016, vegetation is doing well. (May 2021)

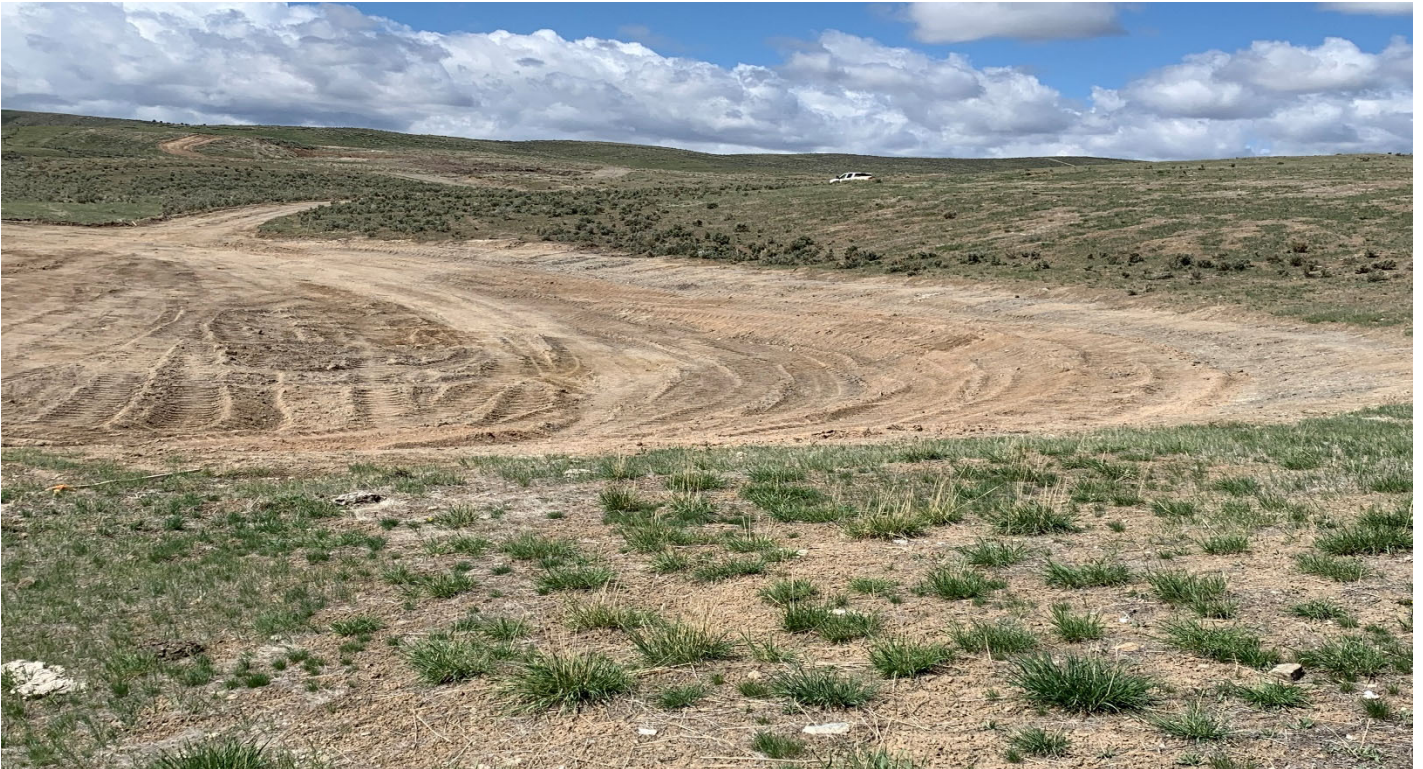
Figure 10: Recent cleaning of the Sediment Control Basin that was originally created in 1999 to prevent off site sedimentation. This has become a multipurpose basin as a water source for the wildlife and BLM grazing allottee. (May 2021)
